Bonita Peak Mining District Update

August 2020

Site Updates

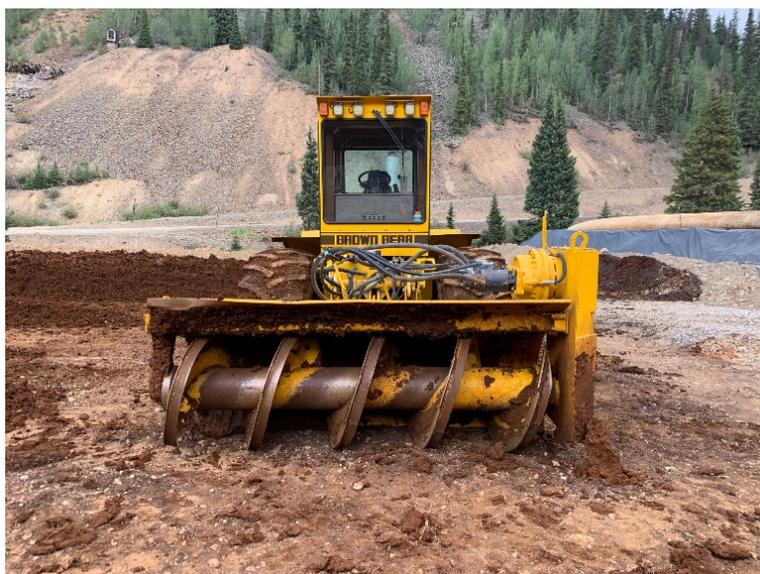
Figure 1 Brown Bear Corp. tractor with auger

EPA continues to review dewatering methods for the IWTP sludge to make transportation, handling, and storage of that sludge more efficient. For three months this summer, EPA is trying out a large tractor specifically designed for sludge. The tractor, rented from Brown Bear Corporation, has a large auger on the front which mixes and windrows the sludge. This turning process exposes more of the sludge to the air and sun accelerating the drying process. EPA is trying the equipment out on its sludge drying pad just below the treatment plant. The overall goal is to remove water from the sludge. By reducing the water content, the volume of the sludge decreases making it more cost effective to transport and manage at a later date. EPA will evaluate the tractor's effectiveness after three months.

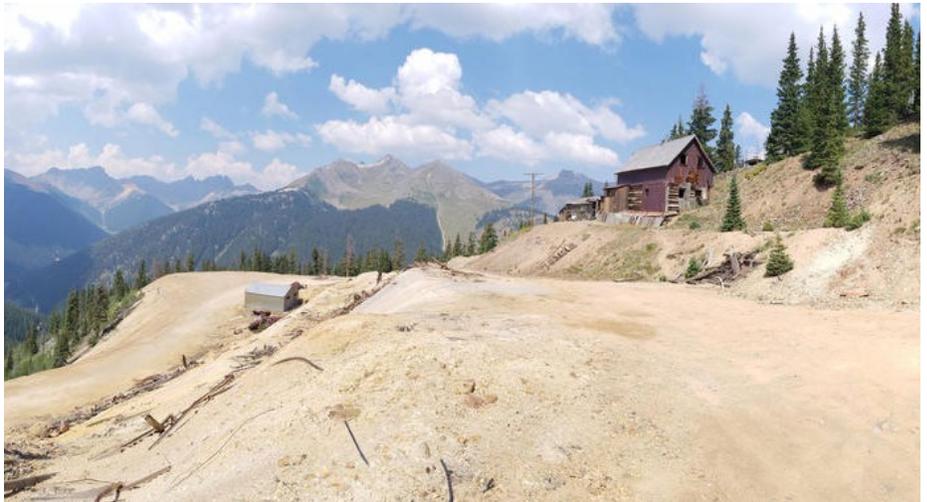
Figure 2 Brooklyn Mine waste rock pile and levels 1 and 2 adit area. Credit USGS

Starting mid-September, the USFS will start work at the Brooklyn Mine. The Brooklyn Mine site consists of four mining levels, termed level one through four. The USFS will work with Colorado Division of Reclamation, Mining and Safety (DRMS) to complete the following site work:

- *Construction of diversion controls.* Run-on control work in the Level One area and in the area of the quarry road, located at the entrance of Level One, will be completed to divert surface water away from waste rock piles below those areas. The existing road to the quarry location will be repaired to implement, maintain, and monitor run on controls that will divert water away from waste rock below the road. This work will be conducted pursuant to the 2019 Interim Record of Decision (IROD).

- **Additional Hazard Mitigation and Debris Removal**
 - *Safeguard Level One highwall.* Interim restoration will be completed at the Level One adit area to address highwall areas created by portal collapse in a popular backcountry skiing and hiking area by lessening the slopes and removing unstable rock and tree hazards at the collapsed portal area.

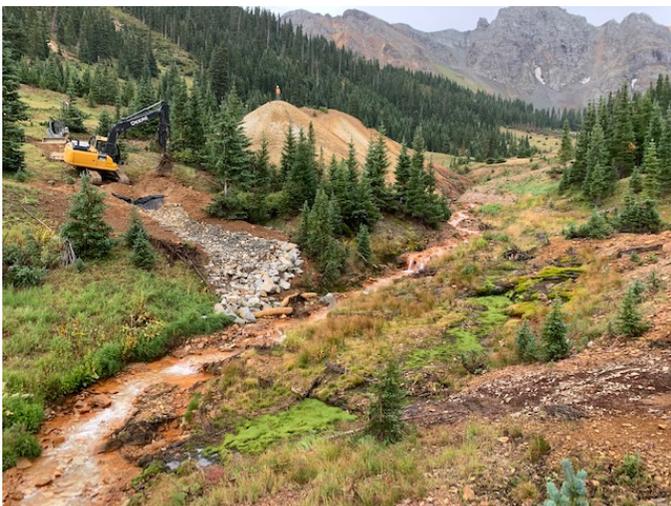
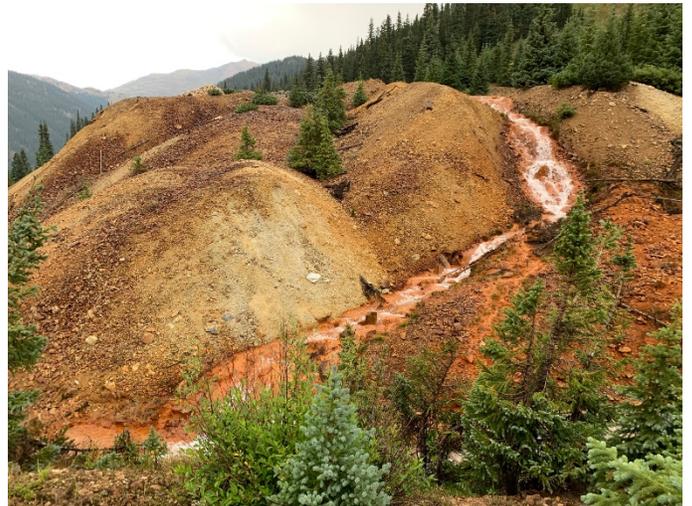
Figure 3 Before IROD work (left) and channel being created to divert adit discharge around waste pile (right)

Site work began on the Natalie/Occidental source area this month. Crews are re-routing the adit discharge away from the waste pile to eliminate erosion and undercutting of the waste pile from the current channel. The portal grate will also be cleared of debris buildup behind the grate to prevent back up of mine discharge and to ensure unobstructed flow to the drainage channel. Figure 3 shows crews creating the new lined channel for adit discharge.
