# Bonita Peak Mining District Update

May 2020

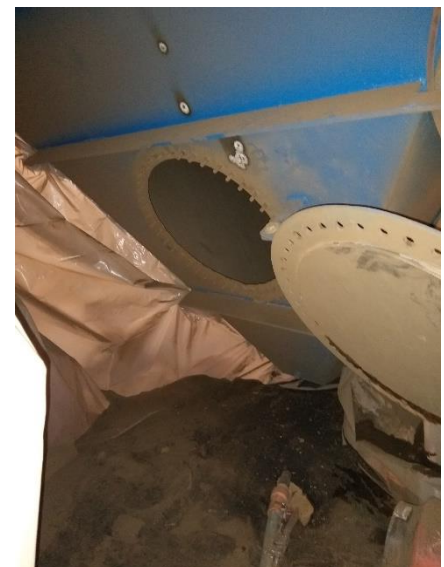
*Clarifier prepped for work and in the process of having the lining removed from the inside.*

For the corrosion repairs of the clarifiers, the existing lining was removed, welding repairs were made, the clarifier was relined, and cathodic protection was installed. The pond desludging and cleaning is done each spring. This process includes adding lime to the sludge and pumping the sludge down to the containment bags located outside of the IWTP.
